# Adiabatic Shear Localization in Titanium and Ti-6 Pct Al-4 Pct V Alloy

H. ANDREW GREBE, HAN-RYONG PAK, and MARC A. MEYERS

Ballistic impact experiments were conducted on 12.5 mm thick commercial purity titanium and Ti-6 pct Al-4 pct V alloy plates using steel "stepped" projectiles with 10.5 mm diameter. The impact velocities varied between 578 m per second and 846 m per second, and a flash X-ray technique was used to determine projectile velocity and to assure the normality of impact. The microstructural damage mechanisms associated with impact (shear band formation, shock wave propagation, and dynamic fracture) were analyzed by optical, and scanning and transmission electron microscopy. Elliptical and spherical cavities were observed along the bands. Microindentation hardness differences between the bands and adjacent regions were slight for the targets; for the projectiles, the hardness in the band was significantly lower than that of surrounding regions. Observation of the fractured regions along the bands showed unique features indicating possible melting. Transmission-electron microscopy of a shear band in titanium revealed microcrystalline features ( $\sim 0.3 \mu\text{m}$

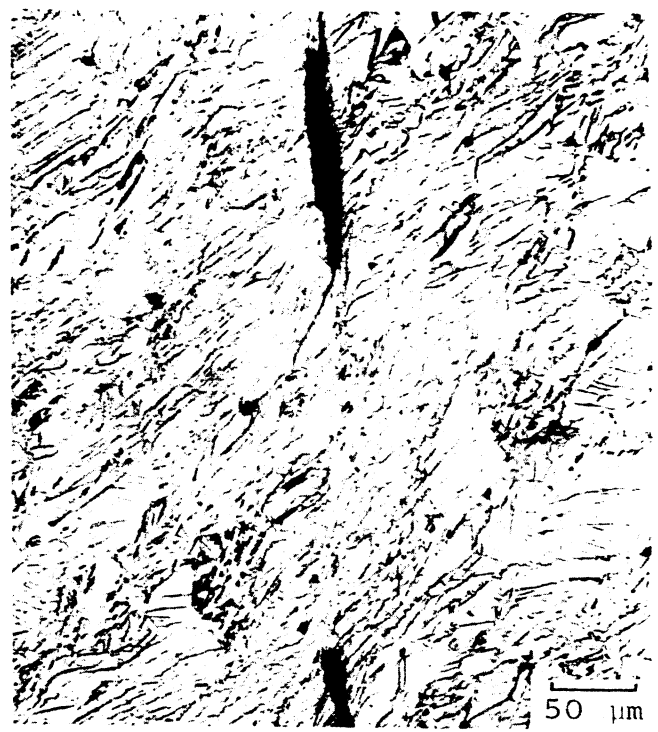
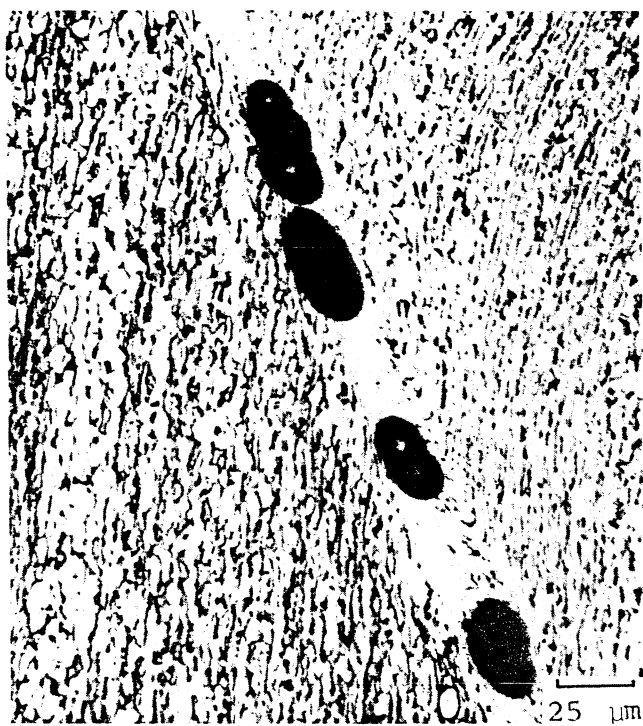
Fig. 8—Voids (a) and blunted cracks (b) in titanium; voids (c) and blunted cracks (d) in Ti6Al4V.

Figure 8 shows the onset of fracture along the shear bands. Voids or elongated cavities were found in both titanium and Ti 6 Al 4V. The cavities were spherical until their diameter reached the thickness of the shear bands; from there on, void coalescence and extension along the shear band resulted in the elongated cavities. Winter<sup>28</sup> and Me-Bar and Shechtman<sup>19</sup> observed similar features. However, it is only by applying the concept of nucleation, growth, and coalescence of voids occurring in spalling that one can understand the formation of these voids in the shear band region. The phenomenon is highly localized in this case because the threshold stress for void nucleation is much

lower. The sphericity of the voids (until their diameter is equal to the band thickness) indicates that the material has high ductility. This preferential nucleation is caused by the higher temperature inside the shear band, with an attendant flow stress decrease. Erlich *et al.*<sup>7</sup> found that lack of tensile stresses after impact (or detonation) resulted in only bands; no voids were observed, leading them to conclude that they are due to the tensile stresses. Rogers,<sup>3</sup> on the other hand, proposed two explanations for the voids: (a) tensile forces (the one corroborated by Erlich *et al.*<sup>7</sup>); (b) growth by cavitation within a heated zone during deformation, atomic mobility at high temperature being responsible for the formation of the spherical voids to reduce surface energy.

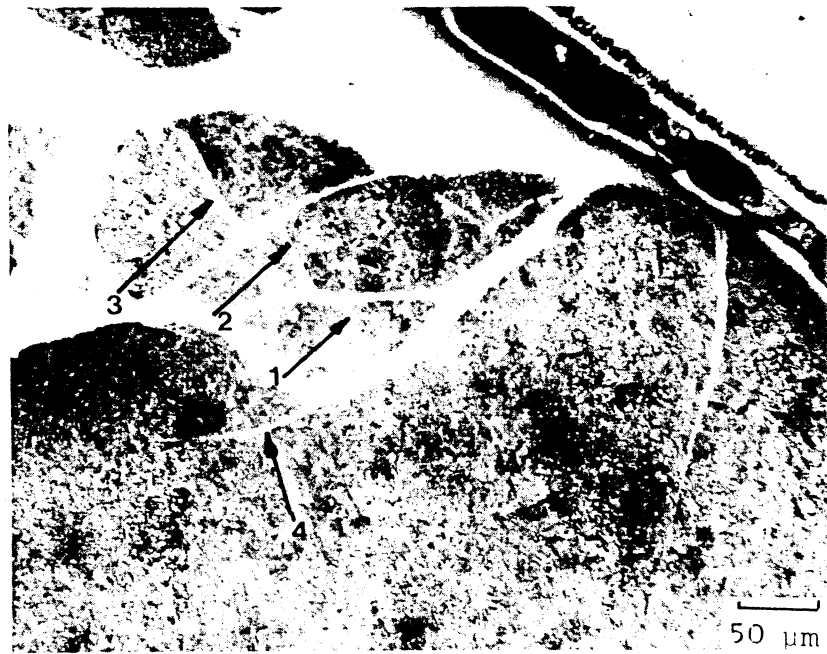
Fig. 9—(a) Shear bands and "islands" in projectile. (b) Sectioned projectile showing "bands" where electron microprobe scans were made.

The projectiles also showed profuse adiabatic shear bands; their arrangement and morphology were quite different than in the targets. The bands showed the characteristic "white etching"<sup>3</sup> appearance and formed a complex interconnecting pattern. This is shown in Figure 9(a). The band indicated by 1, 2, 3 seems to have formed first, transversal bands forming later and establishing steps. Since the projectile is brittle and the pattern of the bands is so irregular, one could speculate that the projectile fragments at the impact interface and that molten metal flows within the crack openings rewelding the projectile. In band 4 (Figure 9(a)) one can see little evidence of shear; however, the band is white. Figure 9(b) shows a section of the projectile embedded in a nickel target; one can clearly see the fragmentation. Electron microprobe scans were made across the white bands in the positions marked in the photomicrograph. No nickel could be detected in any of the scans inside the projectile, discarding the hypothesis that interfacial melting occurred and that liquid metal (a mixture of nickel and iron) would have been injected into the fractured projectile, resolidifying. The composition across the shear bands did not show any inhomogeneities.

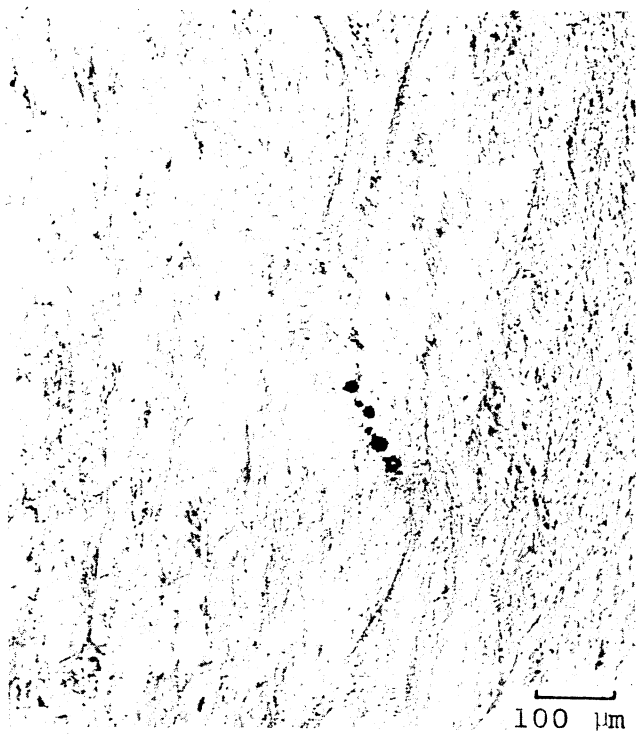
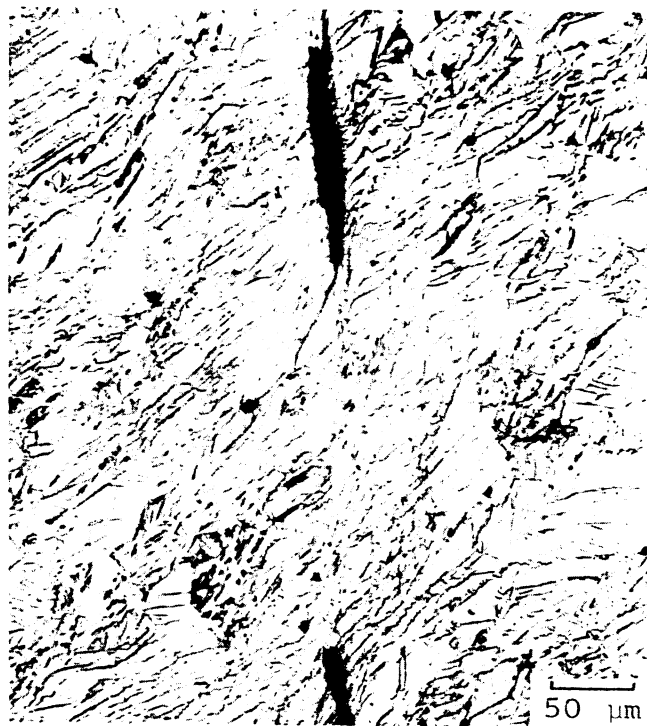
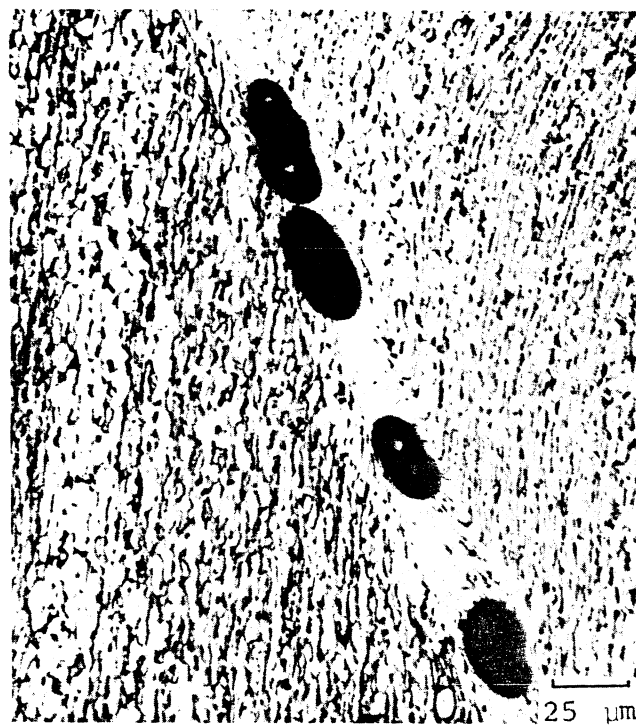
Fig. 8—Voids (a) and blunted cracks (b) in titanium; voids (c) and blunted cracks (d) in Ti6Al4V.

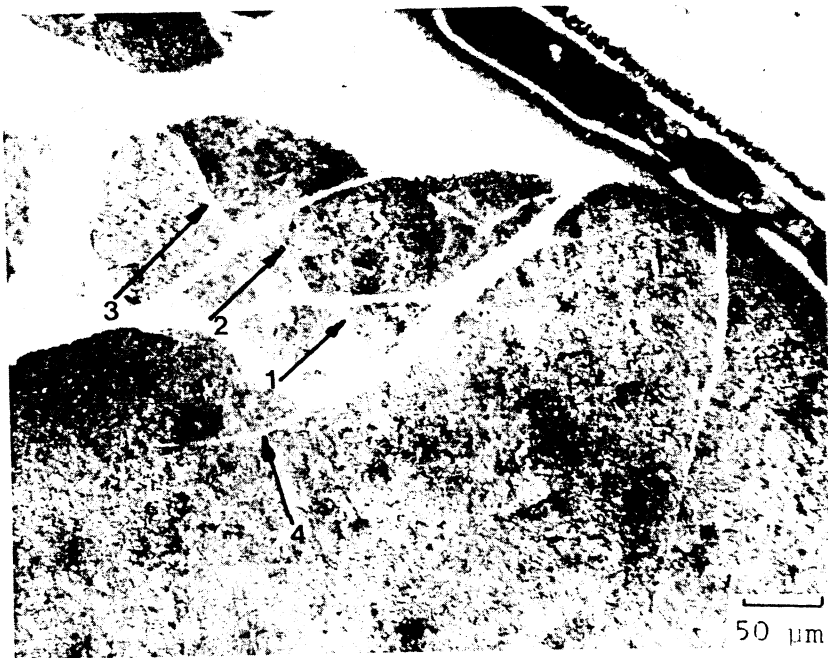
Fig. 9—(a) Shear bands and "islands" in projectile. (b) Sectioned projectile showing "bands" where electron microprobe scans were made.

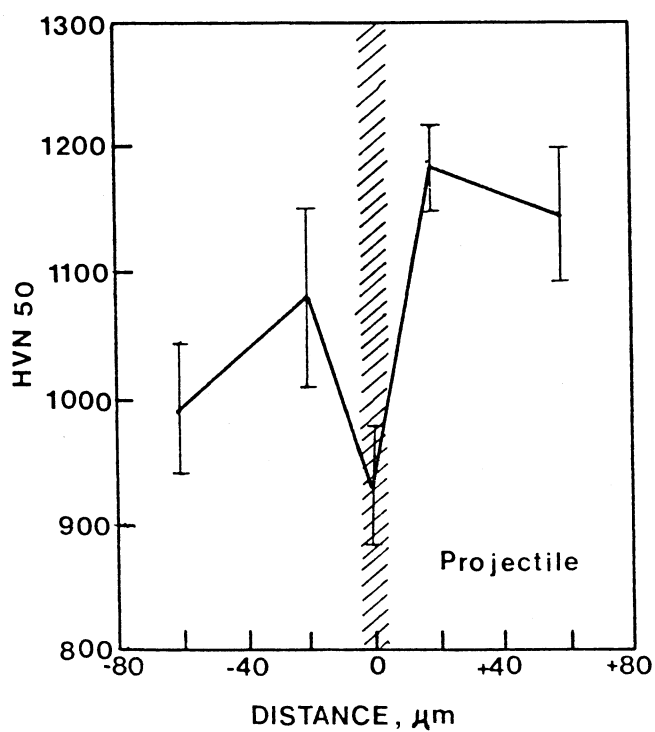
Fig. 10—Vickers microindentation traverses for (a) titanium, (b) Ti6Al4V, and (c) projectile.

The results of the microindentation hardness measurements (each bar represents ten measurements) are shown in Figure 10. For titanium and Ti 6 Al 4V the hardness in the band was not substantially different from the surrounding region. This is in accord with Me-Bar and Shechtman's<sup>19</sup> results for Ti 6 Al 4V but in disagreement with Winter's<sup>28</sup>

results for titanium; he found a substantially higher hardness inside the bands. In the steel projectile, the hardness inside the bands was lower than the surrounding regions. This is in contrast with previous findings for steel. However, the observations reported in the literature<sup>3</sup> refer to regular shear bands and not "islands" as the ones observed in the projectile. An AISI 1040 target, in the quenched and tempered condition, was also subjected to impact. Adiabatic shear bands were observed to form, and their hardness was higher than the matrix. This shows that the white "islands" within the projectiles are different from the conventional bands, and that the cooling rate and forming conditions could be very different.

For the three cases the hardness in the matrix increases as the shear band is approached. This is due to work hardening induced by diffuse deformation surrounding or preceding the localized shear localization phenomenon.

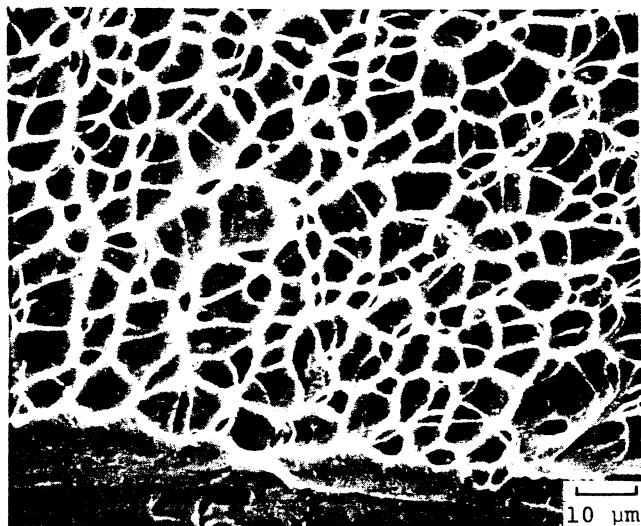
Fig. 11—Characteristic dimples observed in spall region of Ti6Al4V.

Figure 3(b) shows the back side of the targets. Spalling is evident in the specimen marked with an arrow A. It precedes the perforation, since the shock wave propagates in titanium at a velocity of  $\sim 5000$  m per second, while the impact/penetration velocity is lower by roughly one order of magnitude. Hence, spalling has already taken place when the projectile "plugs" through the target. Figure 11 shows a scanning electron micrograph of the spall surface in Ti 6 Al 4V. The characteristic "dimpled" appearance can be seen, showing that this alloy does not lose its ductility at these extreme strain rates.

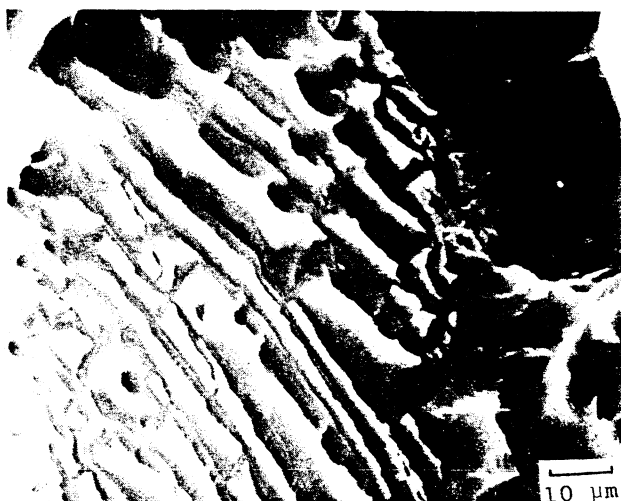
Fig. 14—Fractographs of shear-band crack in titanium: (a) conventional dimpled region and (b) "knobbly" region.

Figure 14 shows the morphology of the fracture inside a band in titanium. One sees regions resembling the ones in Figure 13 (Figure 14(b)) and regions with dimpled morphology typical of titanium (Figure 14(a)). Unique fracture features were also observed by Stock and Thompson<sup>14</sup> and Manion and Wingrove;<sup>29</sup> they called these features “knobbles” and suggested that these features could be due to localized melting. Rogers<sup>3</sup> proposed a mechanism for this “knobbly” fracture by which conventional ductile fracture occurs and is followed by heat generation by friction of the opposing surfaces.

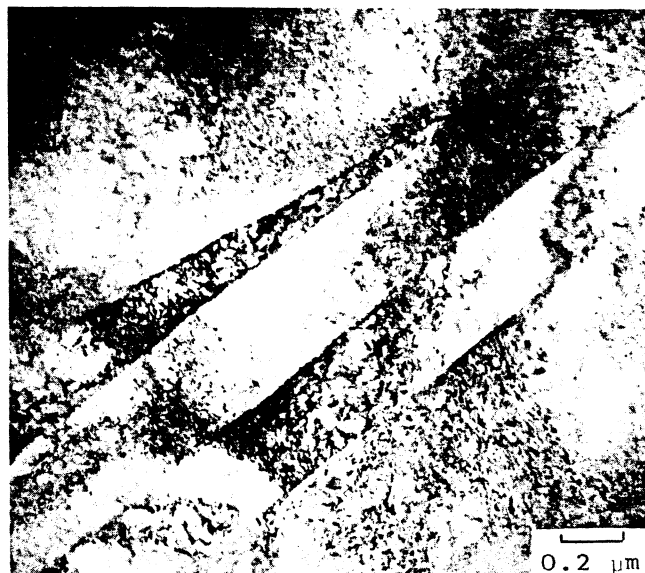
Fig. 15—Substructure produced by impact in titanium.

twinning. Figures 15 and 16 show typical substructures for titanium and Ti 6 Al 4V in areas away from shear bands. For titanium (Figure 15), a random distribution of dislocations and bands was observed. Traces of the bands seen in Figure 16 were parallel to  $\{1\bar{2}11\}$ , and thus these structures are considered to be deformation twins; such deformation twins were also observed by Koul and Breedis.<sup>30</sup>

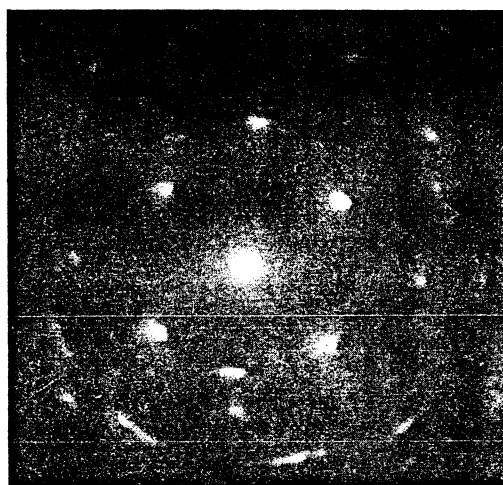
Fig. 18—Microcrystalline features observed within shear band in titanium: (a) bright field; (b) dark field of the same region as in (a) by a spot circled in c; (c) diffraction pattern of A (rings were indexed as  $(1\bar{1}00)$ ,  $(0002)$ ,  $(1\bar{1}01)$ ,  $(1\bar{1}02)$ ,  $(2\bar{1}10)$ ,  $(2\bar{1}11)$ ,  $(2\bar{2}00)$ , and  $(2\bar{2}02)$ ); (d) diffraction pattern of B. Foil plane is nearly parallel to  $(01\bar{1}1)$ .

tion showed both a ring and a spot pattern. The ring pattern, shown in Figure 18(c), was taken from area A (large square) in Figure 18(a). This pattern could be indexed as hcp structure by using lattice parameters ( $a = 2.95 \text{ \AA}$ ,  $c = 4.68 \text{ \AA}$ ) of pure titanium. Arcing of the spots in the pattern is not asterism as usually seen when heavy deformation takes place, but rather indicates a multitude of micrograins. Diffraction rings have been known to be produced if the size of grains is extremely fine ( $\ll 1 \text{ \mu m}$ ).<sup>31</sup> The presence of such fine grains is evident in the dark-field micrograph of Figure 18(b), obtained by using the spot circled in Figure 18(c). Fine, bright areas in the micrograph reveal grains; their size is in the range of  $0.3 \text{ \mu m}$ . These fine grains exhibit some preferred orientation; the diffraction pattern taken from a small area, framed by B in Figure 18(b), shows one single orientation of the hcp structure. It should also be noticed that the boundaries of these fine grains are irregular and not very well defined.

Thus a single crystallographically oriented microcrystalline structure exists for the shear band in titanium. Lattice distortions of up to  $60^\circ$  may have occurred in the shear band; shear band rotation may have occurred causing some preferred orientation. If recrystallization then occurred, this may partly account for the "messy" grain boundaries observed in the band.

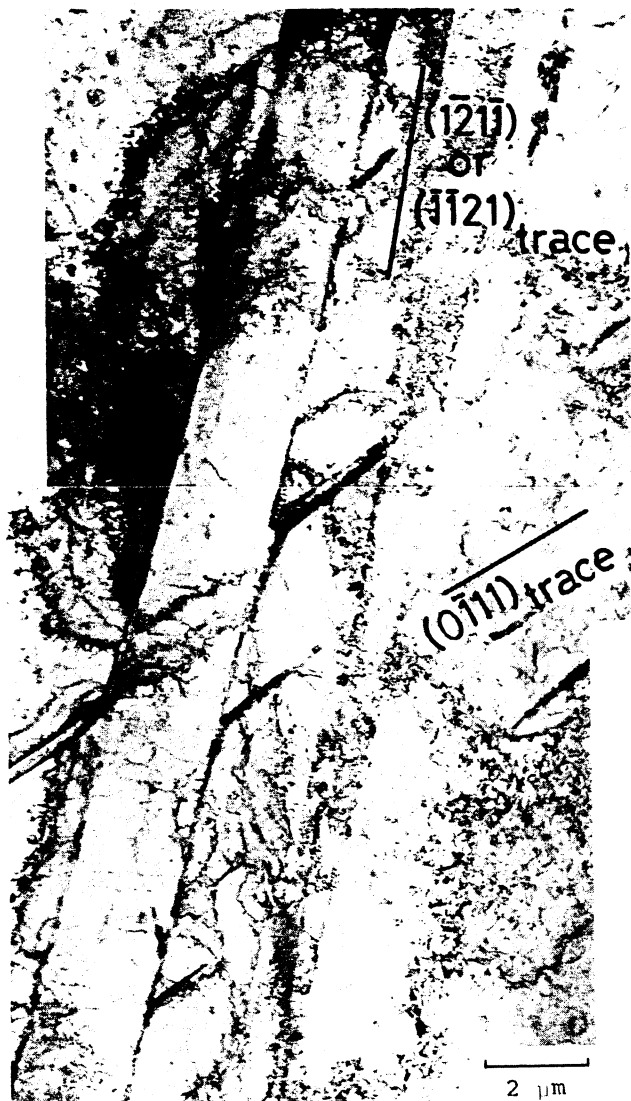
Fig. 19—Appearance of twin variants and dislocation debris in titanium in an area close to the shear band. Foil plane is nearly parallel to (01 $\bar{1}$ 0).

The area very close to the shear band consisted of dislocation debris, and the bright-field micrographs in Figure 19 showed evidence of twinning, considered to having been formed during impact. Trace analysis indicated twins along the  $(1\bar{2}1\bar{1})$  (or  $(\bar{1}\bar{1}21)$ ) and  $(0\bar{1}11)$  planes.
