Metallurgical Applications of Shock-Wave and High-Strain-Rate Phenomena

Effect of Metallurgical Parameters on Dynamic Fracture by Spalling of Copper

SAMUEL CHRISTY, HAN-RYONG PAK and MARC A. MEYERS

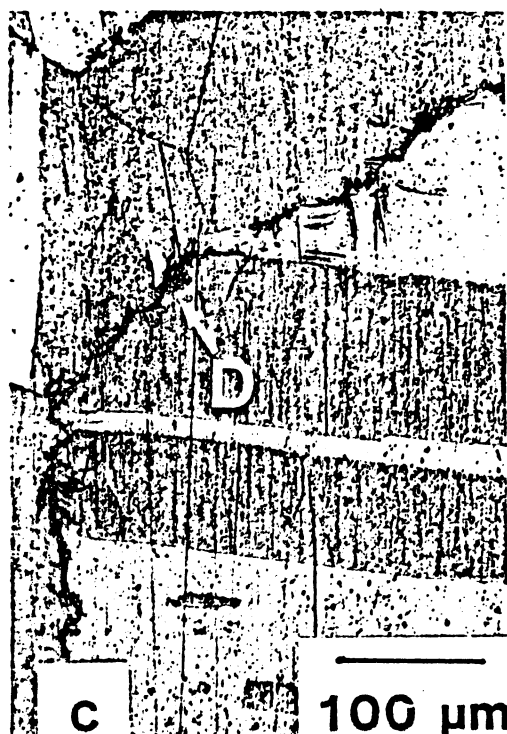
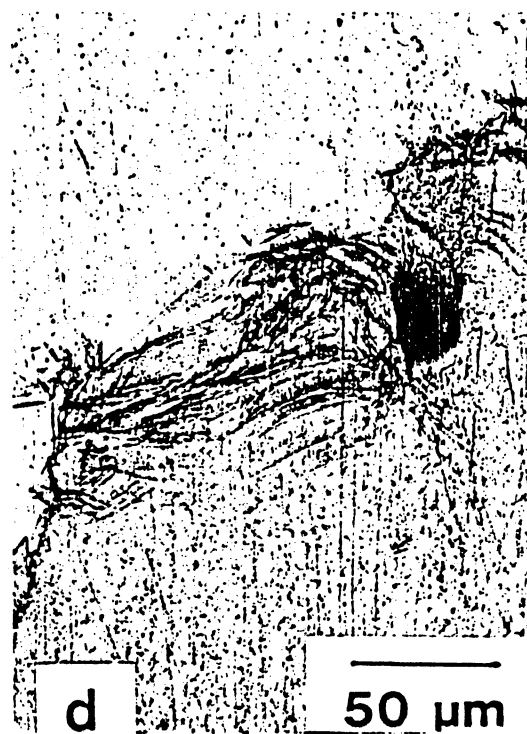
FIG. 8 Optical micrographs of medium grained copper specimen showing (a) nucleation of spherical voids at annealing twins, (b) roughly square voids, (c) and (d) grain boundary sliding.

Figures 8(a) to 8(d) are the micrographs of voids in the medium grain sample showing different morphologies. Figure 8(a) shows initiation of spherical voids at an annealing twin (marked by arrow). Figure 8(b) shows two square voids 'B' and 'C' with 'B' at the grain boundary, and 'C' in the interior of the grain. This observation seems to indicate the anisotropy of plastic deformation of pure copper. If the flow stresses were isotropic, the resultant void would be of spherical shape in order to minimize deformation and surface energy. Similar features were also observed in a nickel specimen by Meyers and Aimone [2] and an aluminum by Stevens et al. [4]. However, the occurrence of geometrical (square, rectangular, triangular) voids was less pronounced in copper than in nickel.

Figure 8(c) shows a micrograph of a typical grain boundary distortion resulting from shear along the grain boundaries (arrow 'D'). The fracture in this case occurs by the shearing action between the two neighboring grains. Another feature of interest in this micrograph is the nucleation of a microvoid within the deformation band indicated by an arrow 'E'. Figure 8(d) also shows plastic localization in the form of a shear band. One can also see the severely deformed grain boundary.

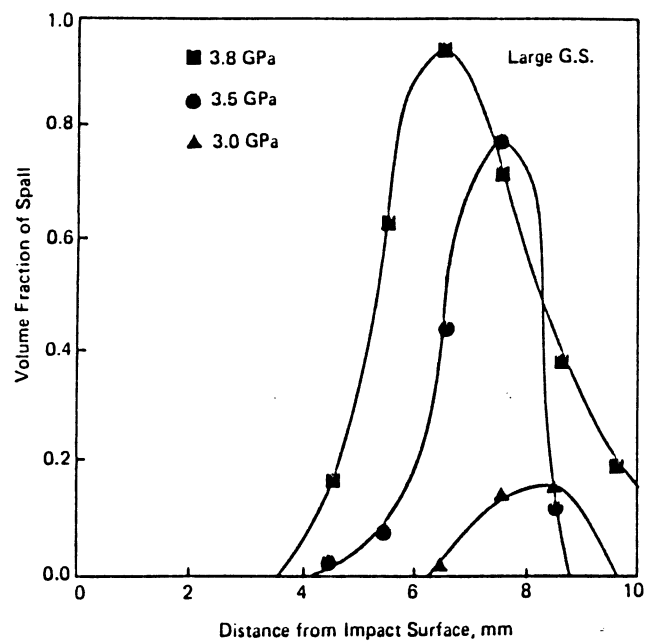
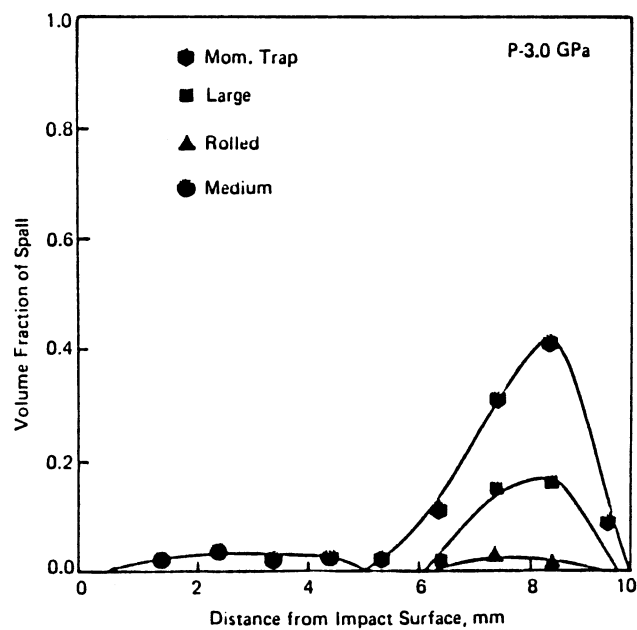
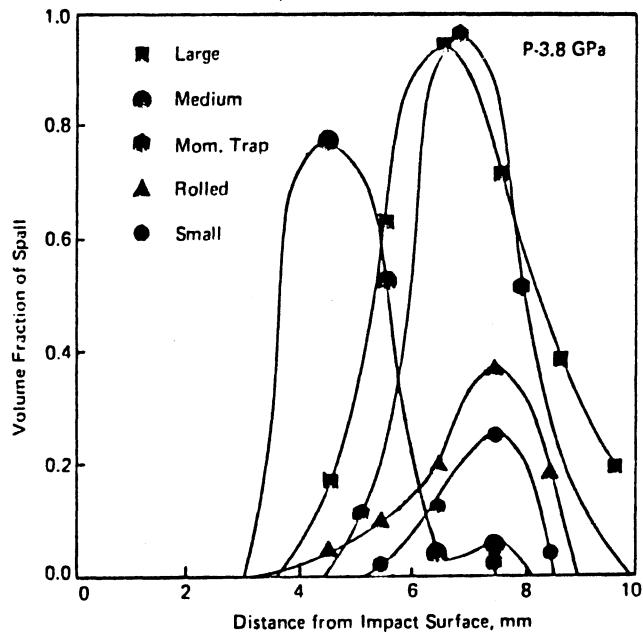
FIG. 15 Volume fraction of voids formed upon spalling: (a) effect of pressure on large grain size specimens; all metallurgical conditions at (b) 3.0 GPa, (c) 3.5 GPa, and (d) 3.8 GPa.

The volume fraction of voids formed upon spalling was computed as a function of impact pressure as well as a function of different metallurgical conditions (large, medium, small, rolled and momentum trap). Figure 15(a) compares the extent of spall fracture in large grained copper specimens, as a function of impact pressure (3.0, 3.5, and 3.8 GPa). One notices that the amount of spall damage increases with increase in impact pressure. Figure 15(b) shows the variation of volume fraction of voids computed in large grain, medium grain, small grain, as-rolled, and momentum trap specimens subjected to a pressure of 3.0 GPa. It can be seen that the momentum trap has sustained the maximum amount of damage compared to large and medium-grain size copper. The rolled specimen, on the other hand, shows very little volume fraction of fracture. Small grained specimens do not show any damage at this stress level. This indicates that the small grained specimen exhibits superior dynamic fracture resistance compared to the other specimens. The momentum trap has a much higher density of second-phase particles and at this stress level a large number of these particles (heterogeneous sites) can be activated more rapidly than other nucleation sites (homogeneous) present in the large grained, medium grained, small grained, and rolled copper specimens.

Figure 15(c) compares the spall damage of different specimens impacted at 3.5 GPa pressure. The large grained specimen exhibits the heaviest damage. The rolled specimen, on the other hand, shows superior spall resistance. In the case of specimens impacted at 3.8 GPa pressure [Fig. 15(d)], the momentum trap, large grained and medium grained copper specimens show a higher amount of damage compared to small grained and rolled specimens. The position of the peaks corresponds to the position of the spall plane, where these materials may have experienced the first tensile pulse. As the metal spalls, the stress experienced by adjacent regions is reduced because of the release waves generated at the free surfaces.
